REPAIR INSTRUCTION NO. RI-1078-92/1

G 115E / EG all as affected

Repair of hinge bracket attachment point – RUDDER and VERTICAL STABILISER

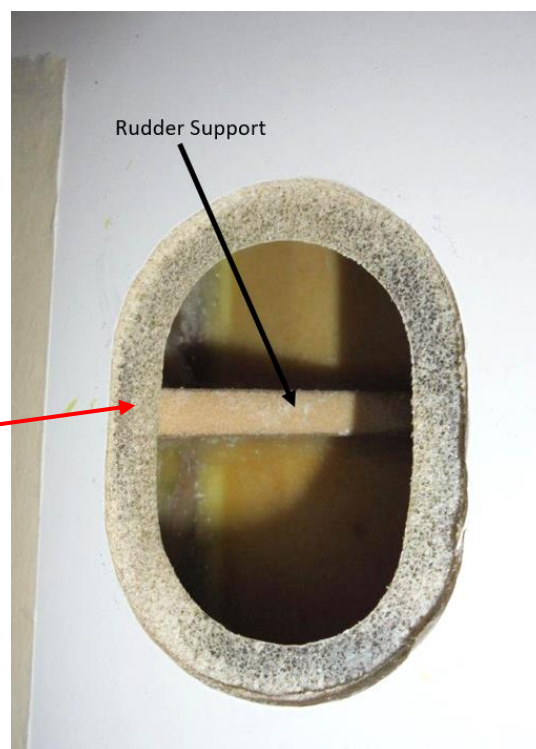
Figure 2: Rudder support installed on top of center attachment point

Note: For S/N 82086 – 82273 the rudder support is installed on top of the center attachment point. It must be removed for the repair to gain access to the bolts. Note the location where the support is installed for later re-installation of a new rudder support (item 8 of List 9).
